“Generator Field Winding Shorted Turns: Observed Conditions and Causes”

DJ Albright and DR Albright, Generatortech, Inc.

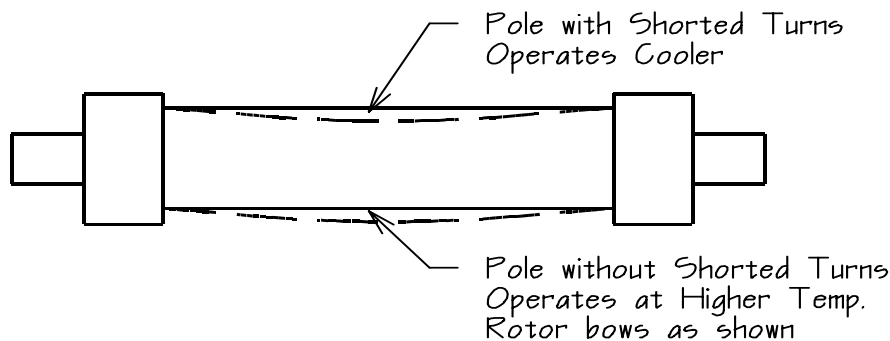
Figure 2 - Rotor Bow Due to Shorted Turns

The most likely problem with operation in the presence of shorted field windings is excessive vibration. Vibration in *two pole* rotors occurs due to uneven heating of the rotor forging. When turn shorts cause an unequal distribution of active turns between poles, the amount of heat (I^2R losses) between poles is also unequal. This unequal heating will cause the rotor to bow and thereby introduce vibration. The coil location of turn shorts is the key to determining if the rotor will experience vibration problems. In general, unequal turn distribution in smaller coils (1,2, 3) will have a greater effect whereas unequal turn distribution in the larger coils will have a lesser effect. For instance, one could expect vibration problems with only 5% shorted turns in the # 1 coil of one pole of a seven coil rotor where no vibration problems would be expected if the same percentage of turn shorts were present in the # 6 or # 7 coils. Figure 2 depicts the rotor bow due to shorted turn conditions.

One telltale sign of shorted turn induced vibration is the variation of vibration magnitude on increase in load. Increased field current increases differential heating on the rotor forging, increasing bowing and subsequent vibration. Some machines are observed to show the opposite effect. That is, the rotor vibration decreases with increase in load. When this is the case, it is clearly the effect of compensation balancing that has been done to offset shorted turn induced vibration levels at load. The balancing weights were placed to compensate for rotor bowing at full load, but actually throw the balance off at lower loads when rotor bowing is not as great.

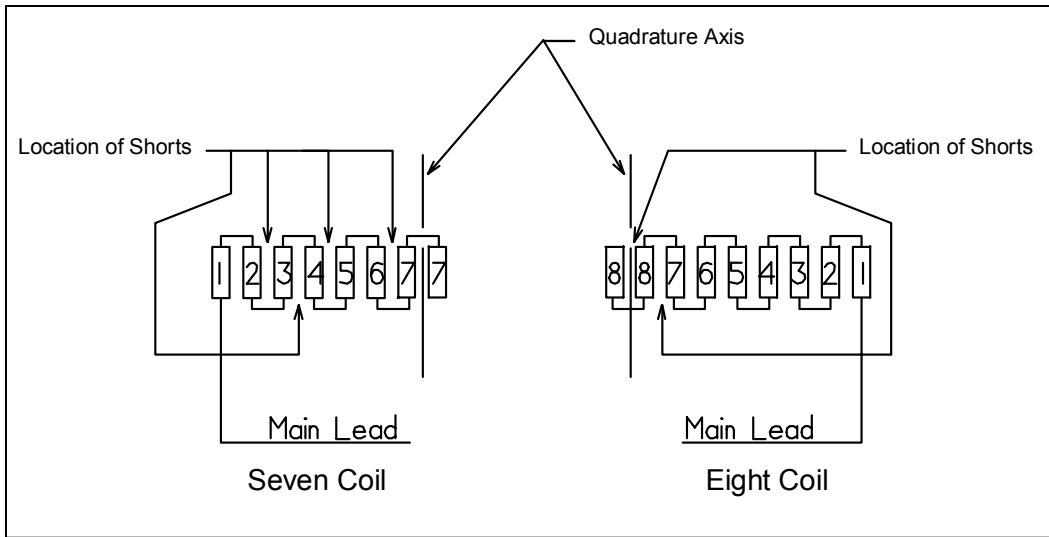
The most serious condition caused by shorted turns is arcing damage to the retaining ring. The cases we have observed are those where the top turn of one coil comes into contact with the top turn of an adjacent coil. The arcing from this contact will burn through the retaining ring insulation and cause a defect in the retaining ring itself. A structural defect in the retaining ring is a very serious condition requiring immediate shutdown due to the danger to plant personnel. This type of shorted turn condition will give either a momentary or sustained field ground indication. Once a ground indication is found, flux probe testing should be conducted to determine if shorted turns are present. Any flux probe test that shows that entire coils are out of the field circuit should lead to the suspicion that retaining ring damage may have occurred.

Figures 3, 4 and 5 relate to our observations of cases of coil-to-coil shorts. Figure 3 shows the locations that coil-to-coil shorts have been observed. Figure 4 is a sample of flux probe test data showing a coil-to-coil short. Figure 5 is a photo of a short between coils 6 and 7 of a seven-coil field.

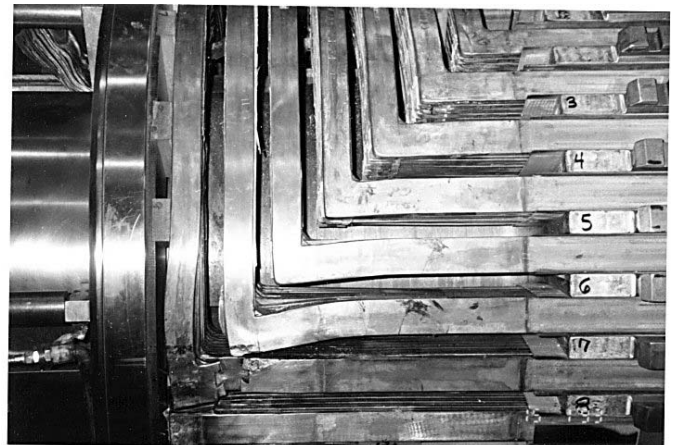
Figure 5-Elongated Coil 6 contacts Coil 7

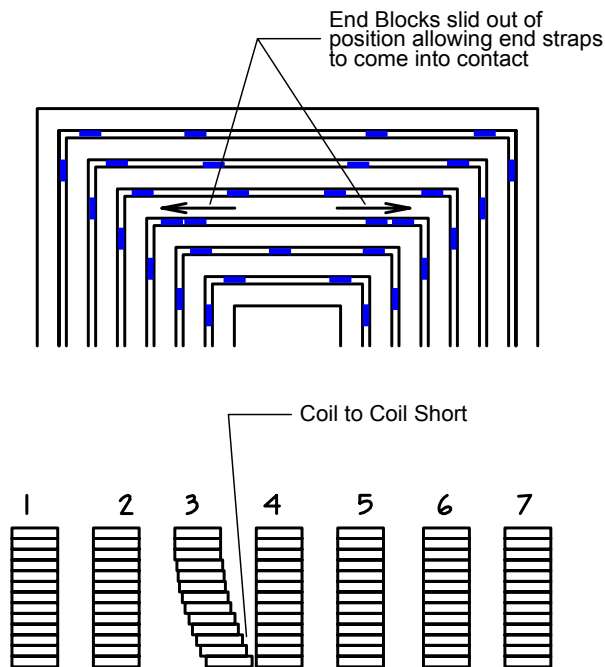
Although not as prevalent as other turn short causes, end-winding blocking problems have been the cause of a number of shorted rotor winding conditions that we have observed over the years. The purpose of end-winding blocking is to maintain the alignment of the end-windings during operation. The cases observed by Generatortech are either missing blocks or blocks that have moved out of position as shown in Fig. 6. Most blocking arrangements have been developed and/or refined by manufacturers through experience with past problems. Service organizations should pay close attention to the manufacturers recommendations for blocking installation during rewinding.

Figure 6 –Coil Short due to migrating end blocks

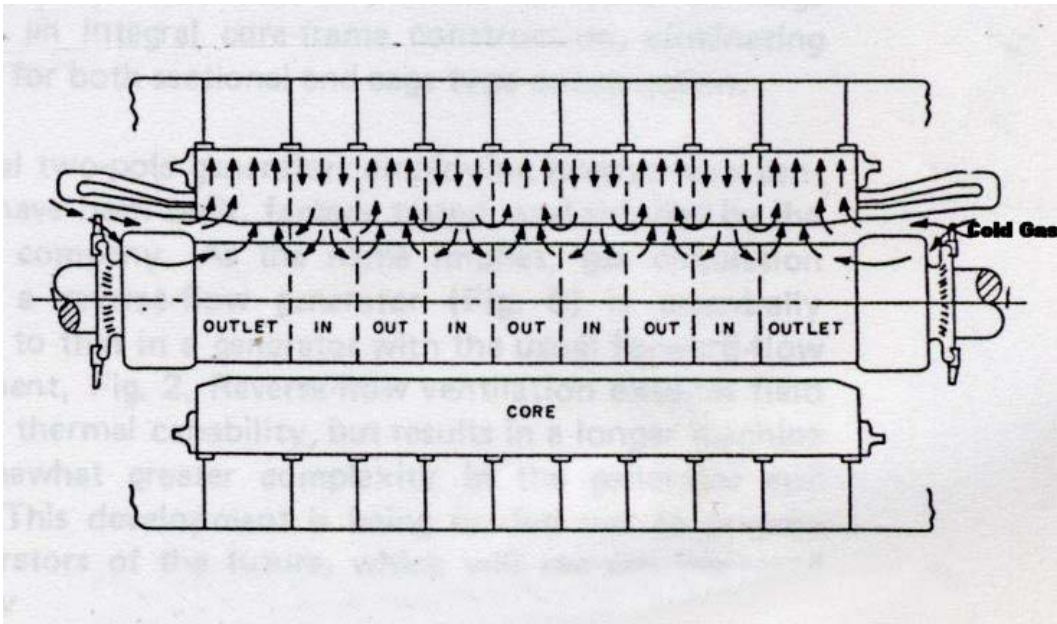
Figure 7 - Ventilation Circuit

One area where this contamination based creepage path has created a problem is at the inner surface of the retaining ring insulation. Figure 7 shows the ventilation circuit in one generator design configuration. The gas from the axial fan flows directly under the retaining ring to the end winding copper.

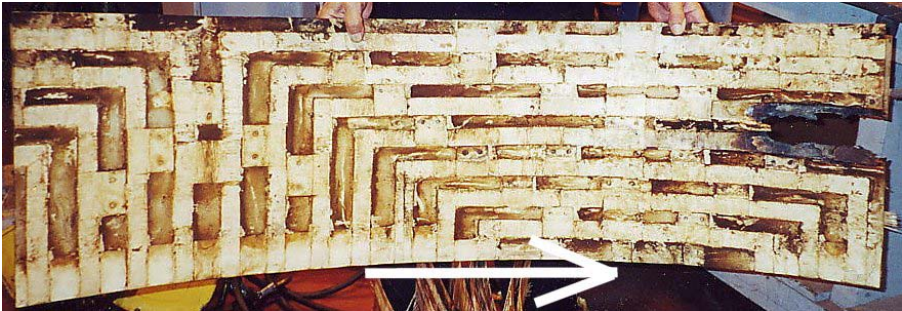
Contaminants are impinged on the inner retaining ring insulation surface due to centrifugal forces. Moisture, introduced to the cooling gas, by any number of ways, will be absorbed by the contaminants creating a conductive bridge between coils. Creepage paths in this location have caused coil-to-coil failures. (Fig. 8 and 9) On air-cooled generators, hand wrapping of the top one or two turns may aid in precluding this type of failure.

Fig. 8 – Burned R.R. Insulation Contaminant Induced Coil-to-Coil Short

Figures 8 and 9 show the after effects of a Coil 4 to Coil 5 short to the retaining ring. Both coils were shorted out. Figure 8 is the inner layer of the ring insulation from an air-cooled generator. Similar conditions have been observed in hydrogen cooled generators. The light colored areas are the outlines of the end windings and blocks. The dark areas are contaminants deposited by centrifuge action on the retaining ring insulation surface. Note the rotational direction arrow and note that the heaviest buildup of

contamination is at the leading edge of the blocking. It has been our experience that coil-to-coil shorts due to contamination normally occur at the leading edges of the blocks.

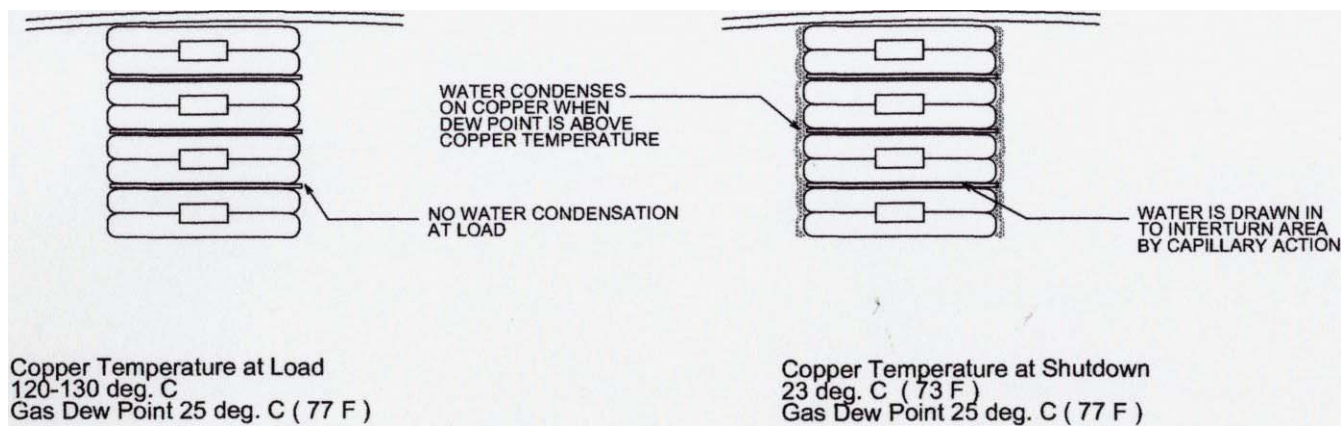
The contamination/moisture problem also occurs between individual turns in the end-winding region. Although the mechanism that deposits the contamination is not fully understood, it is likely that a combination of a number of physical effects is at play. The physical evidence of contamination between turns, however, is clear. The most likely scenario to fit the observations we have made is that condensed moisture is drawn into the space between turns during cool down by capillary action. This capillary action also draws contaminants into the space. Moisture condenses on critical areas during cool down when the dew point of the cooling gas is higher than the surface temperature copper windings. (Figure 10)

Figure 10 – Condensation of Water on End Windings due to High Dew Point of Cooling Gas

Our experience to date shows that the presence of moisture in the cooling gas is a significant problem when faced with the presence of contaminants. In hydrogen-cooled generators, close attention to the operating dew point should be made. The dew point should be controlled to be below 7.5⁰ C (45.5⁰ F) at the operating hydrogen pressure. Consideration should also be given to utilizing hydrogen dryer system if necessary.

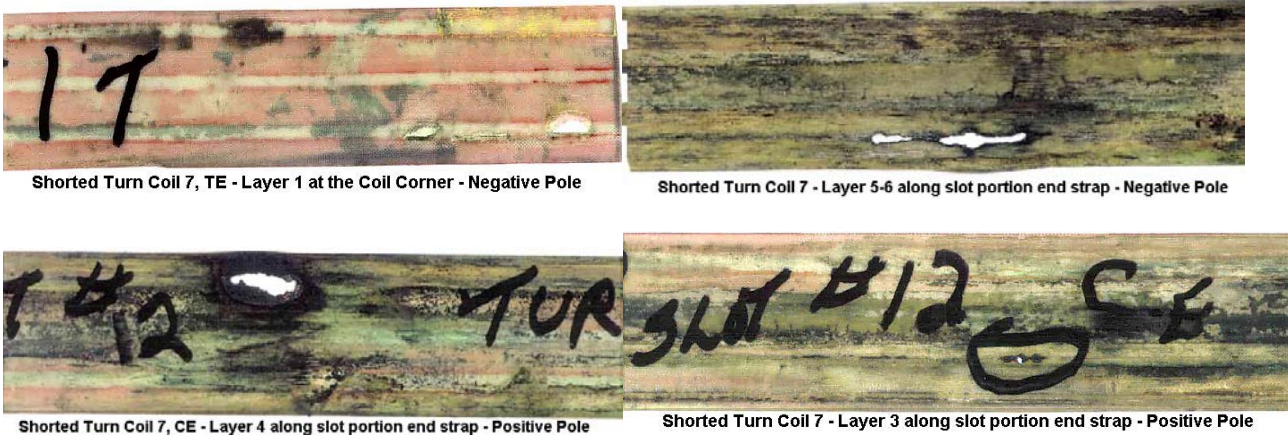
Once the contaminants are in place between the turns and the generator is put back in service, very high stresses in the interturn insulation, at the contaminant location, are developed. The presence of moisture further degrades the fiberglass interturn insulation. The combination of degraded insulation, high stress and a conductive path of moist contamination provides a very short turn-to-turn creepage path. (Approx. 0.015”) which will result in a spot weld between turns. The heat generated during the “welding” burns the interturn insulation. Figure 11 depicts 4 different sections of interturn insulation from shorted turn locations.

Figure 11 – Samples of Interturn Insulation with Shorted Turn Evidence

Once the small initial spot weld is formed, it is frequently broken due to relative turn-to-turn movement during start/stop cycles. Because of an oxide coat that forms on the surfaces of the broken initial weld, a subsequent spot weld will occur adjacent to the original location. This process can continue causing larger and larger holes in the interturn insulation.

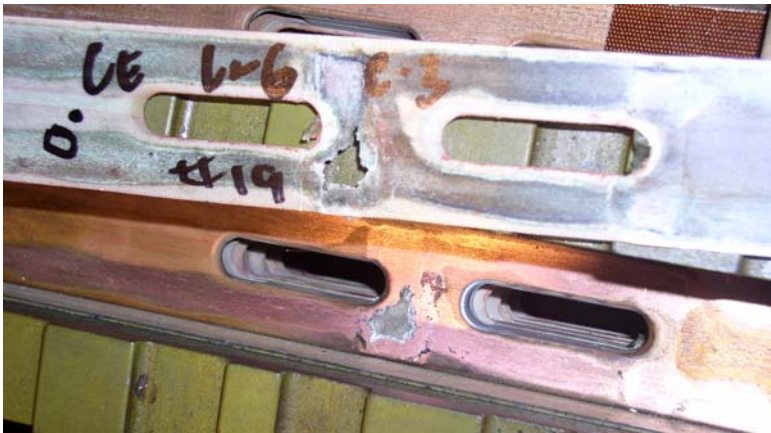
A recent case presents a dramatic relationship between moisture and the development of a very high level of shorted turns. The generator in question was producing about a gallon of water per day from the H2 detraining trap. Flux probe tests showed that the generator was suffering from a large number of shorted turns that were distributed among many of the coils in the rotor. The rotor was recently disassembled during an outage to rewind the rotor and over 100 turn shorts were in evidence. Most of these turn shorts were located in the rotor body (Figure 12), which is in contrast to the other generator that suffered severe turn shorts related to moisture contamination.

Figure 12 – Samples of Interturn Insulation with Shorted Turn Evidence
